DEPARTMENT OF TRANSPORTATION

Quality Assurance and Source Inspection

Contract #: 04-0120F4Cty: SF/ALA Rte: 80 PM: 13.2/13.9File #: 69.28**WELDING INSPECTION REPORT****Resident Engineer:** Pursell, Gary**Address:** 333 Burma Road**City:** Oakland, CA 94607**Report No:** WIR-001294**Date Inspected:** 15-Jan-2008**Project Name:** SAS Superstructure**OSM Arrival Time:** 1930**Prime Contractor:** American Bridge/Fluor Enterprises, a JV**OSM Departure Time:** 730**Contractor:** Zhenhua Port Machinery Company, Ltd (ZPMC), Changxing Island **Location:** Shanghai, China**CWI Name:** Ye Yongjun**CWI Present:** Yes No**Inspected CWI report:** Yes No N/A**Rod Oven in Use:** Yes No N/A**Electrode to specification:** Yes No N/A**Weld Procedures Followed:** Yes No N/A**Qualified Welders:** Yes No N/A**Verified Joint Fit-up:** Yes No N/A**Approved Drawings:** Yes No N/A**Approved WPS:** Yes No N/A**Delayed / Cancelled:** Yes No N/A**Bridge No:** 34-0006**Component:** Caltrans Mock-Up**Summary of Items Observed:**

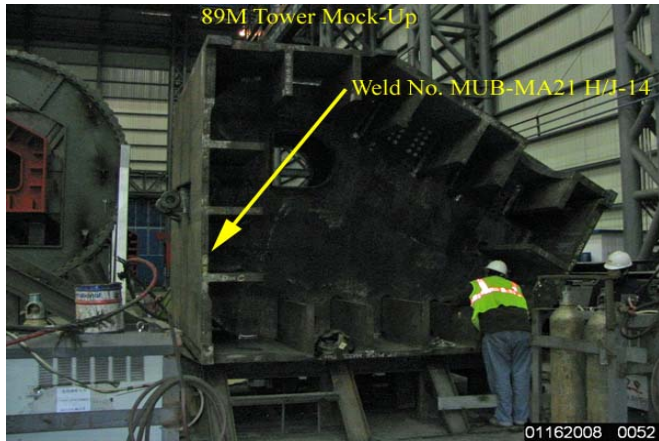
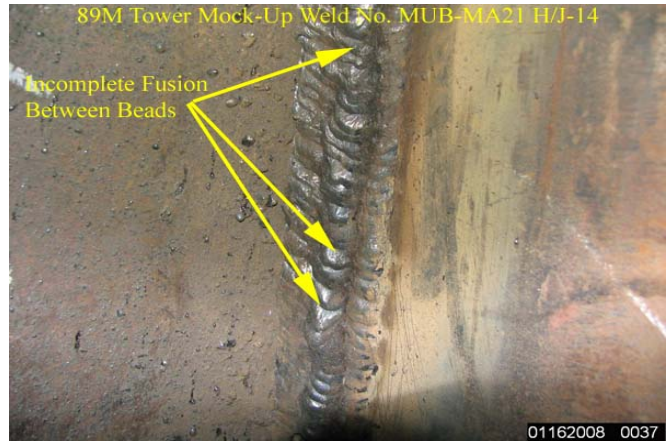
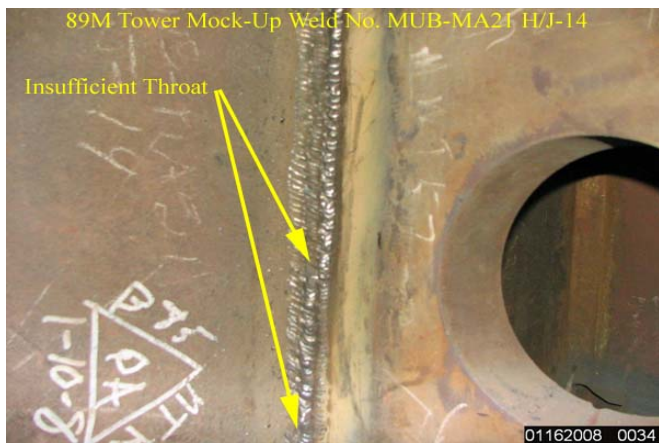
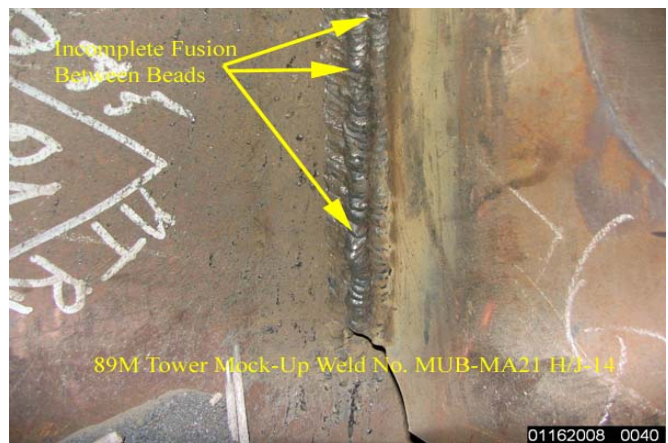
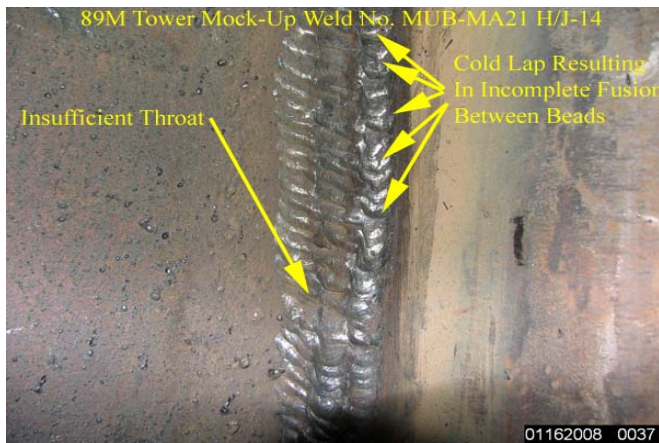
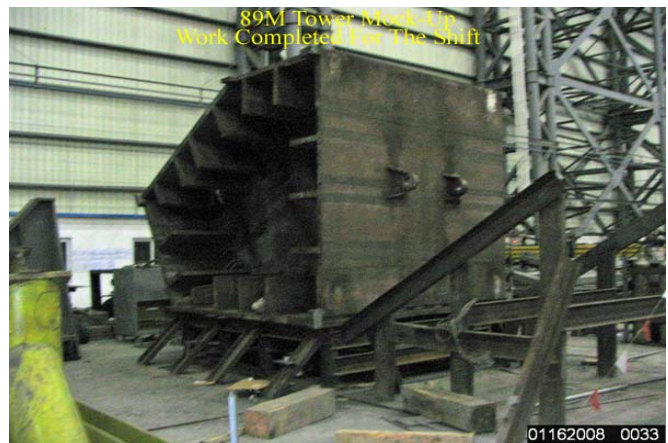
The Caltrans Inspector observed the completed Weld No. MUB-MA21 H/J-14 on the 89M Tower Mock-Up. It was observed that ZPMC CWI, Ye Yongjun (AWS CWI No. 07031461) had apparently visually accepted this weld. The QA Inspector observed that this weld is visually unacceptable in accordance with AWS D1.5-2002, paragraph 3.6 and Figure 3.3 due to insufficient throat and incomplete fusion between weld beads. See attached pictures.

These observations do not appear to meet the requirements of the job specifications.
